MAGNETIC PERTURBATION INSPECTION OF INNER BEARING RACES

by John R. Barton and James Lankford

SOUTHWEST RESEARCH INSTITUTE

NATIONAL AERONAUTICS AND SPACE ADMINISTRATION • WASHINGTON, D. C. • MAY 1972

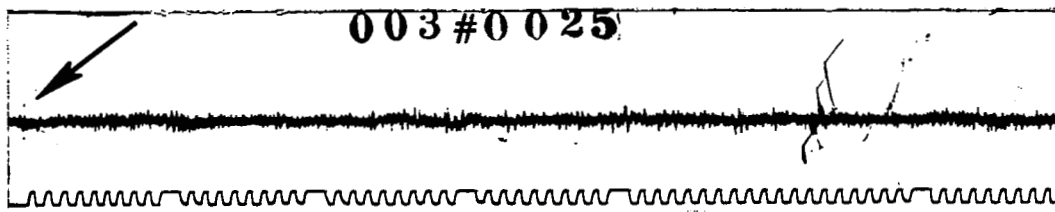
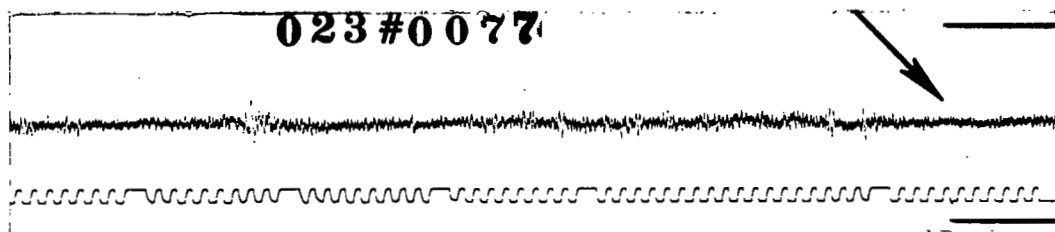
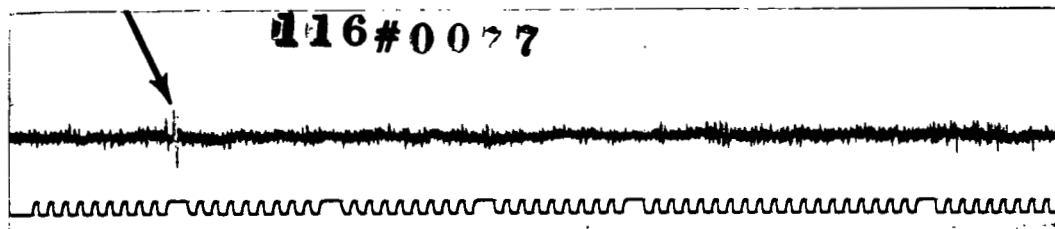
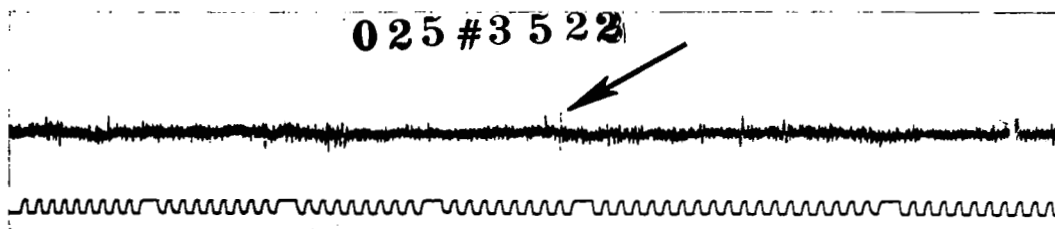
Selected inspection records from several specimens which showed an "inclusion type" signal are shown in Figures 8 and 9. In each instance, the signal of interest has been indicated by an arrow. The specimen serial number and the location of the track across the specimen groove is also shown. For example, the first trace (Figure 8(a)) is from specimen No. 3 with the track centered at 2.5° . The flaw signal at the arrow is located at approximately 5° circumferentially as determined by referring to the circumferential angular marker. This is the general type of signal obtained from an inclusion; namely, the signal when examined from 0° toward the 360° location first goes downward and then upward, and this "polarity" is typical of inclusion signals and/or voids. Such signals will be called "void polarity." On other specimens rather pronounced signals which have a polarity opposite to an inclusion signal have been observed; these will be called opposite polarity. An excellent example of the latter is shown on the record from specimen No. 116 at the 55° circumferential location (Figure 8(c)).

FIGURE 8. INSPECTION RECORDS WITH TYPICAL SIGNALS (PRIOR TO ENDURANCE TESTING). SIGNAL IN (c) IS OF OPPOSITE POLARITY.

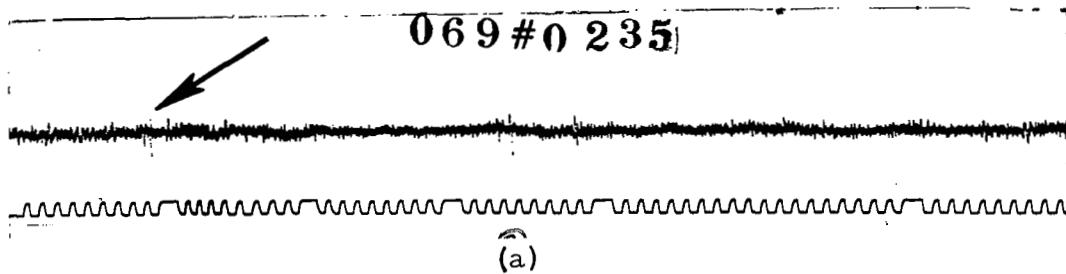
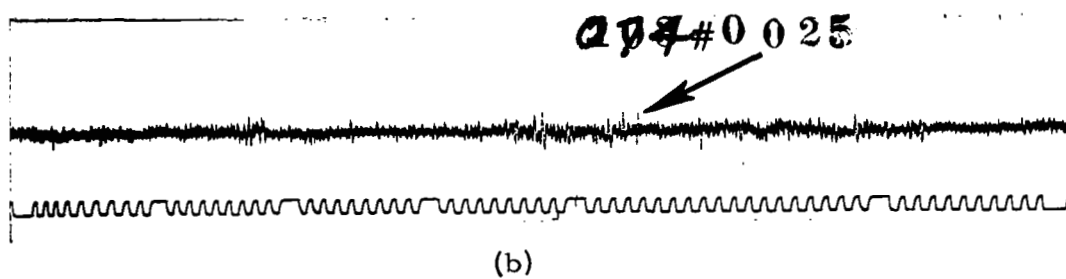
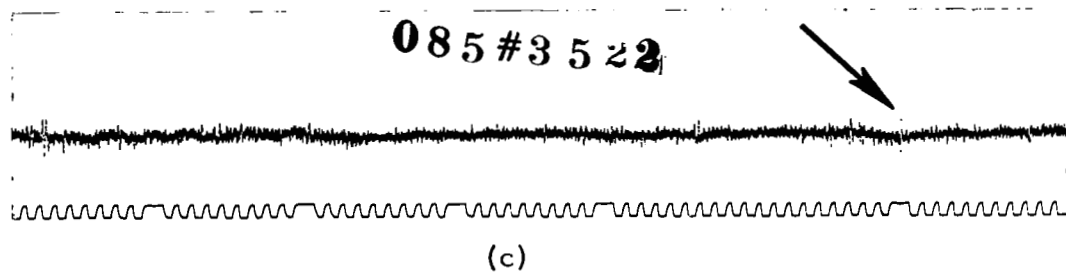
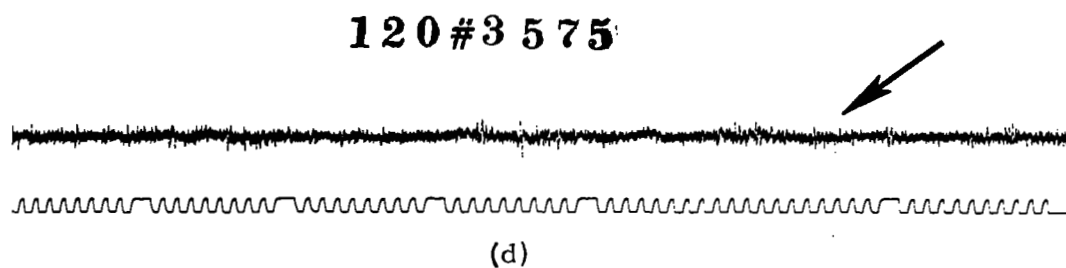
FIGURE 9. INSPECTION RECORDS WITH TYPICAL SIGNALS (PRIOR TO ENDURANCE TESTING)

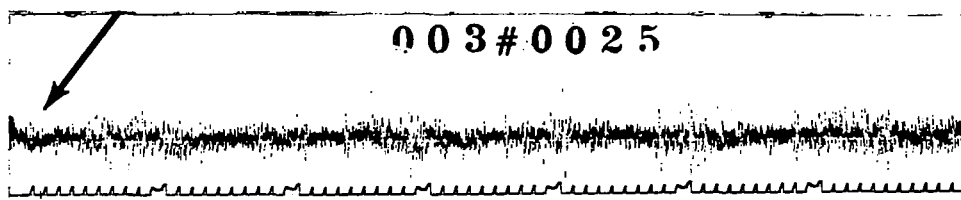
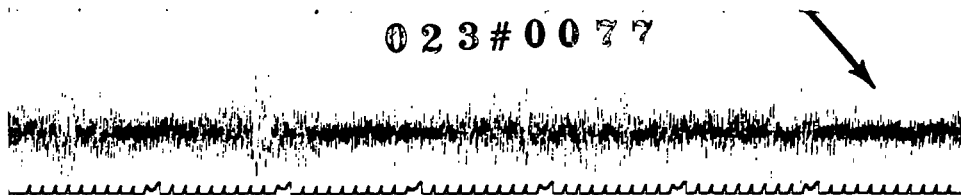
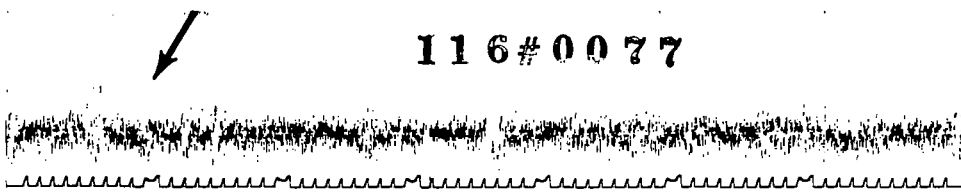
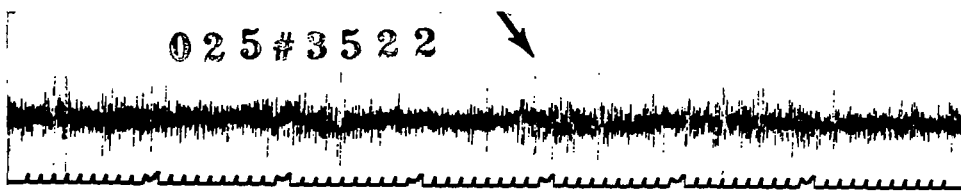
A number of inspection records taken following endurance testing of 54 bearings are shown in Figures 11 and 12. Where applicable, the signal corresponding to an earlier, pre-endurance test signal has been marked with an arrow; these data should be compared with Figures 8 and 9, showing the pre-run data. It is interesting to notice that the average background signal amplitude appears to have increased significantly, frequently making it difficult to locate an initially highly visible signal. Actually, it will be seen later that most of the defect signal amplitudes have changed little. The background has remained essentially constant, although in a few instances may have increased slightly. It should be pointed out that in estimating signal amplitudes in millivolts, the Polaroid expanded records are employed, and the precise probe positioning is adjusted by hand for maximum signal resolution. This procedure helps in bringing the signal out of the background, as shown in Figure 10. The apparent background increase can be attributed to the fact that a probe differing in sensitivity from that employed for the pre-endurance run data was used in recording the later Linagraph data; a probe identical to the earlier one was used in taking expanded signal data. By utilizing recognizable background features, it is possible to pick out defect signals, and to establish the precise location of the defect relative to the bearing race. This aspect of the work will be discussed further in Section II. D. 2.

FIGURE 11. INSPECTION RECORDS WITH TYPICAL SIGNALS (SUBSEQUENT TO ENDURANCE TESTING). SIGNAL IN (c) IS OF OPPOSITE POLARITY.

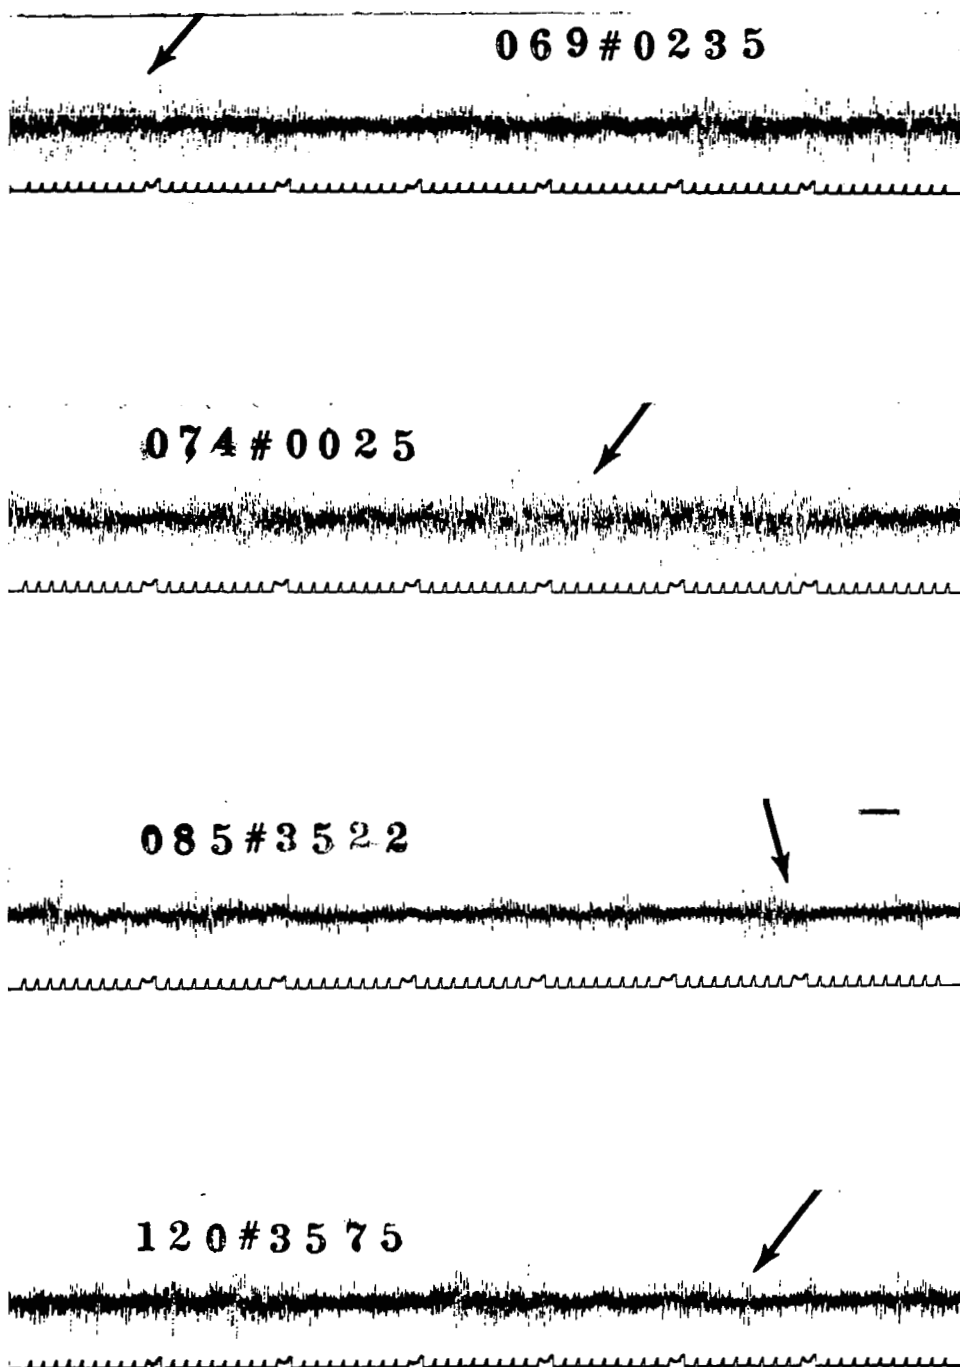
FIGURE 12. INSPECTION RECORDS WITH TYPICAL SIGNALS (SUBSEQUENT TO ENDURANCE TESTING)

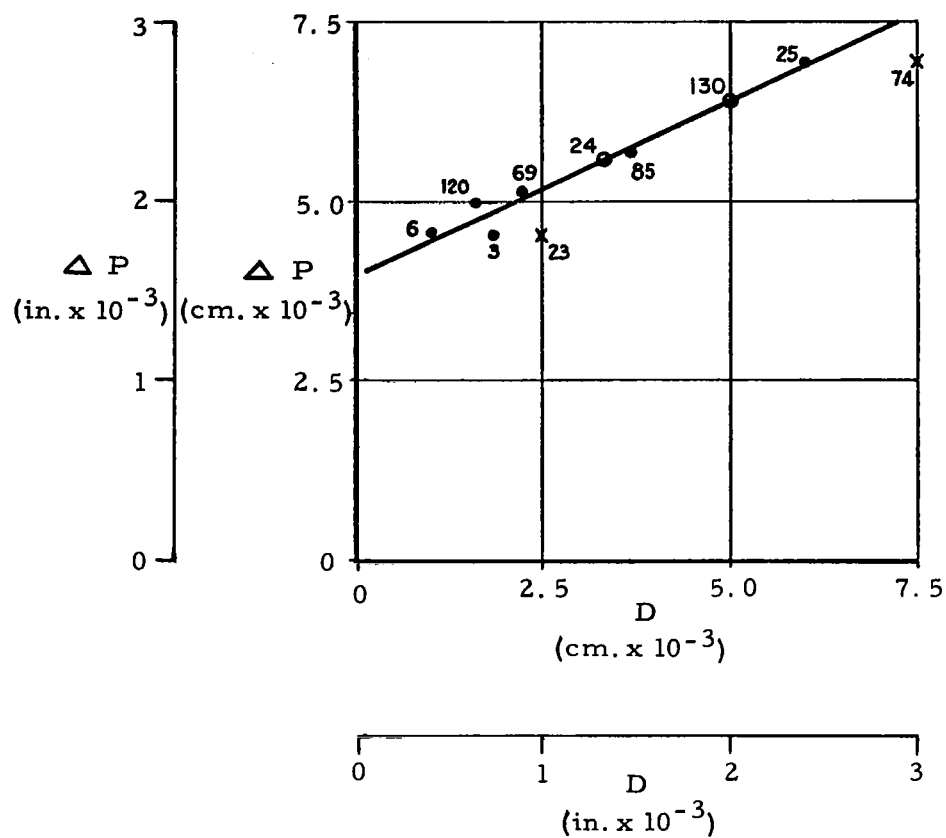
FIGURE 22. (cont'd) (b) PLOT OF ΔP VERSUS D FOR SEVERAL DEFECTS

Two of the specimens, numbers 24 and 130, experienced spall nucleation at large amplitude void-polarity signals. It is interesting to note that aside from that of specimen No. 85, the defect signal-to-background ratios for the above two inner races were the largest recorded, i. e., 6:1. Of greater importance was the fact that the absolute signal amplitude, which is related to flaw size, was 67 mV for No. 24 and 58 mV for No. 130. Not only were these the two largest signals, but the axial locations (7.7° and 357.5° , respectively) were well within the highly stressed zone covering $\pm 10.5^\circ$, shown in Figure 28. Further, recalling Figure 22(b), it is possible to calculate the apparent depth of the defects corresponding to these two signals,

From the data of Figure 22(b), it is apparent that the linear relationship between ΔP and depth may constitute a powerful method for assessing the damage potential of a given defect. Whether or not an inclusion lies sufficiently deep to be affected by the subsurface (Hertzian) plastic zone may have a strong influence on its relative propensity for crack nucleation although this point still is subject for conjecture, and requires further study. It was previously noted that butterflies were observed only in those instances wherein the nucleating inclusion lay within the plastic zone (Figure 26), while microcracking was observed both above (near-surface) and within the plastically deformed region.

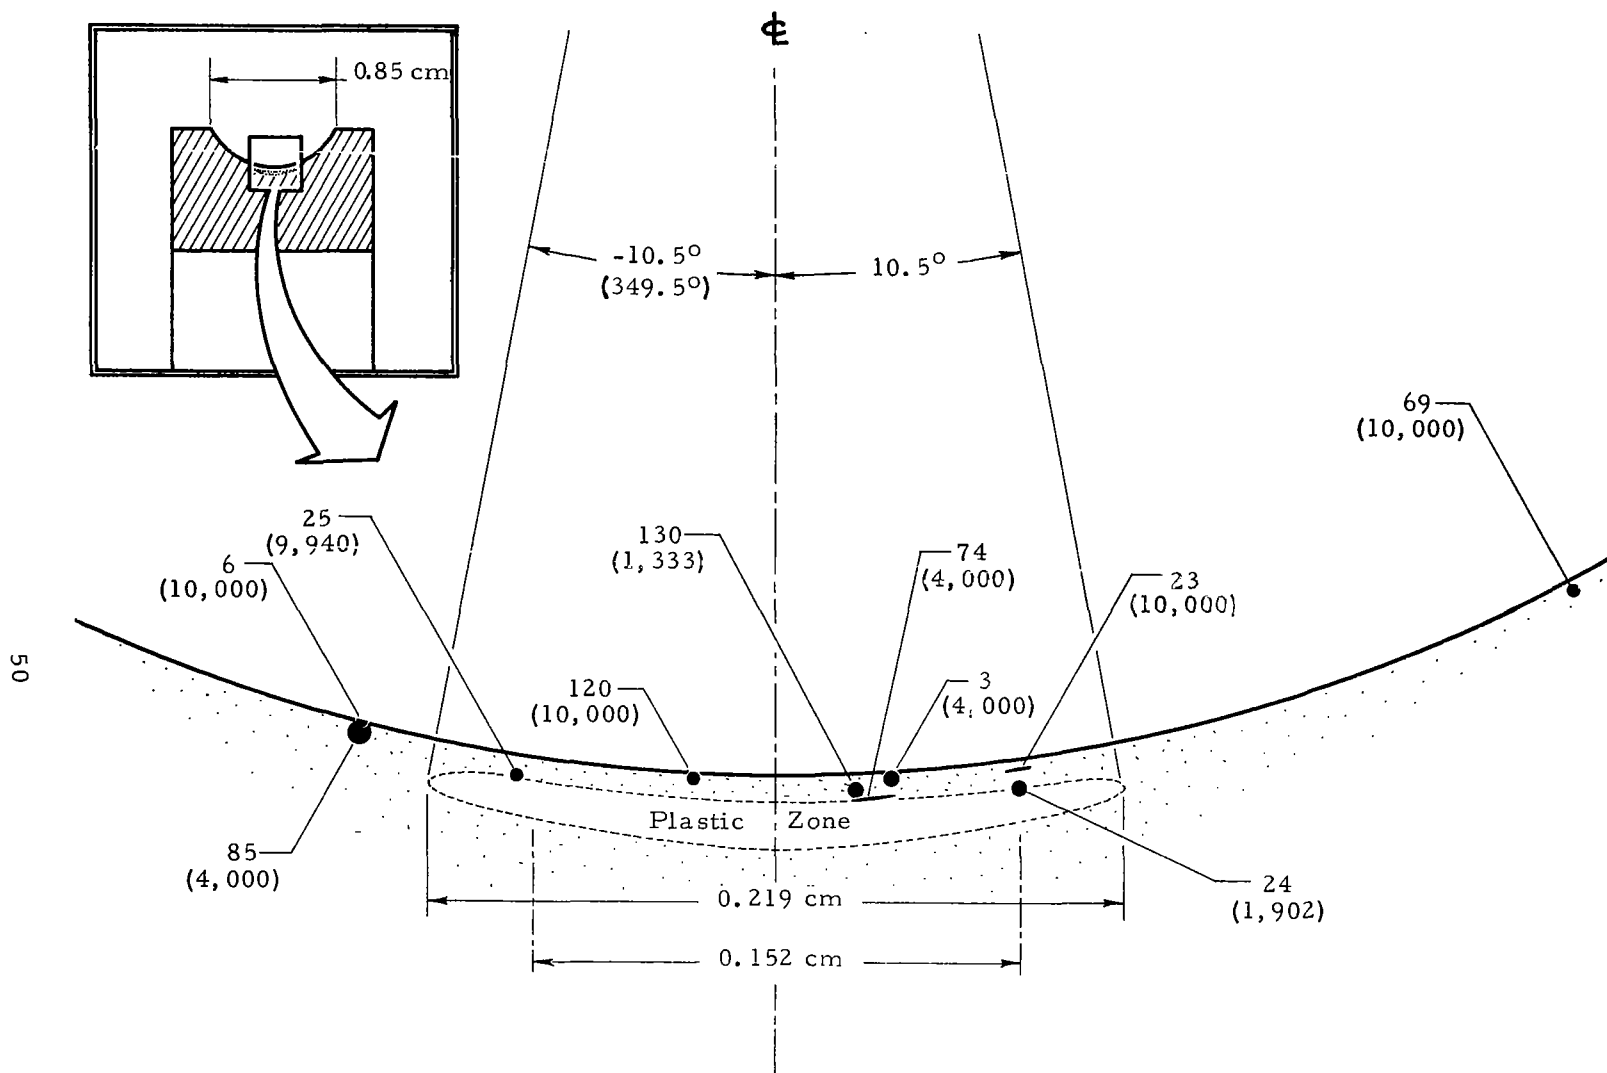
It is useful at this point to consider the results of the inspection, endurance testing, and sectioning in terms of actual and potential inclusion-related failure. During the following discussion it will be extremely useful to refer to Table III and to Figure 28. The latter figure shows the locations, relative size, and depth of the inclusions located during metallurgical sectioning, relative to the race surface and to the subsurface plastically deformed zone.

FIGURE 28. SCHEMATIC SHOWING DEFECT LOCATIONS AND SUBSURFACE PLASTIC ZONE
(Lifetimes in hours listed as subscripts)

as indicated by the open circles plotted on the experimental curve, for the observed peak separations. Note that the defect which caused specimen No. 130 to fail was probably deeper than that responsible for the spalling of No. 24. In general, one would have expected No. 130 to develop severe plastic deformation and microcracking sooner than No. 24, since it would have been closer to the region of maximum orthogonal shear stresses, which lay approximately 0.012 cm (0.005 inch) below the surface, on the basis of etching characteristics. Specimen No. 130 apparently just entered the upper edge of the plastically deformed subsurface zone at the 0.0056 cm (0.0022 inch) depth, which No. 24 did not. It is significant, then, that the former specimen failed after only 1333.3 hours, yet No. 24 survived for 1902.7 hours, half again as long.
